Manhole Inspection Summary

Manhole # S53M__062MH

Insp Date: 7/21/08 1:32 PM

Location Address: **rear 3133 dillon st**

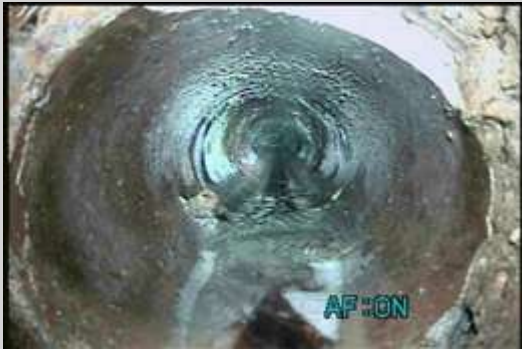
12 O'Clock Outflow

8 in. Circular Gravity Sewer
Pipe Out @ 12 O'Clock

Pipe Material: **Clay** ☐ Pipe Lined

Invert Depth: 9.00 (ft.) Flow Characteristics: **Fast**

Infiltration: **None** Pipe Seal Cond: **Unknown**

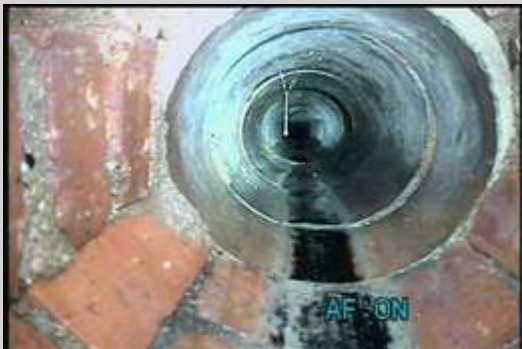
3 O'Clock Inflow

8 in. Circular Gravity Sewer
Pipe In @ 3 O'Clock

Pipe Material: **Clay** ☐ Pipe Lined

Infiltration: **None** Pipe Seal Cond: **Unknown**
